# Radon Measurement Report

4160 State Rd  
Akron OH 44319

**Prestige Home Inspections**

<b>Date:</b> 1/13/2019	<b>Time:</b>	<b>Report ID:</b> 2017-Radon-Smart
<b>Property:</b> 4160 State Rd Akron OH 44319	<b>Customer:</b> William Smart	<b>Real Estate Professional:</b>

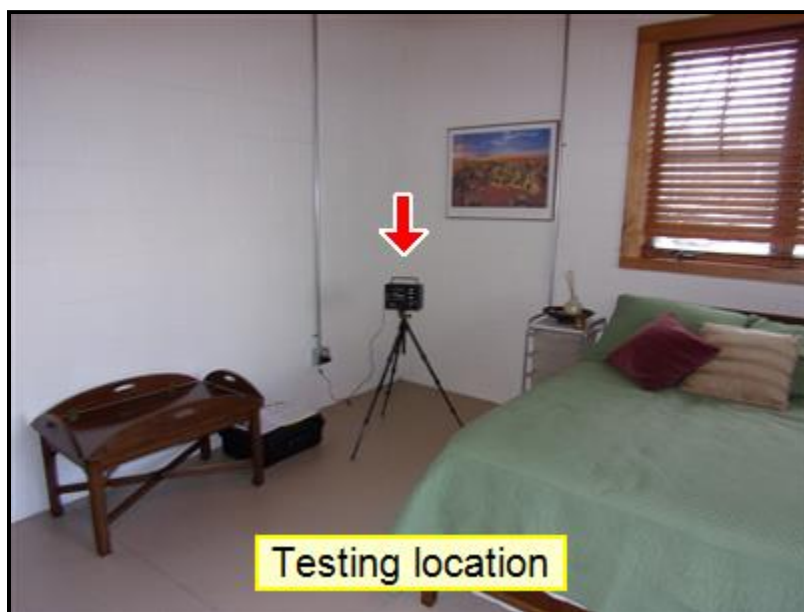
1.3 Picture 1

**🏠 1.3 Measurement guidelines:**

3' from exterior doors and windows: Yes

1' from exterior walls: Yes

20" from the floor: Yes

4" from objects: Yes

4' from fireplace or furnace: Yes

10' from sump crock or pump: Yes
